## GENERATOR REFURBISHMENT REPORT

<b>Location :</b>	Main Component Workshop	<b>Technician :</b>	Jake Mason, Daniel Vincent, Jack Evans, Ben Appleby
<b>Client :</b>	Ynni-Teg	<b>Date :</b>	17/07/2025 - 10/10/2025
<b>Generator Type :</b>	G48-G2	<b>Installation Date :</b>	05/09
<b>Serial Number :</b>	2316	<b>Technical Data :</b>	2Y-530V-465A

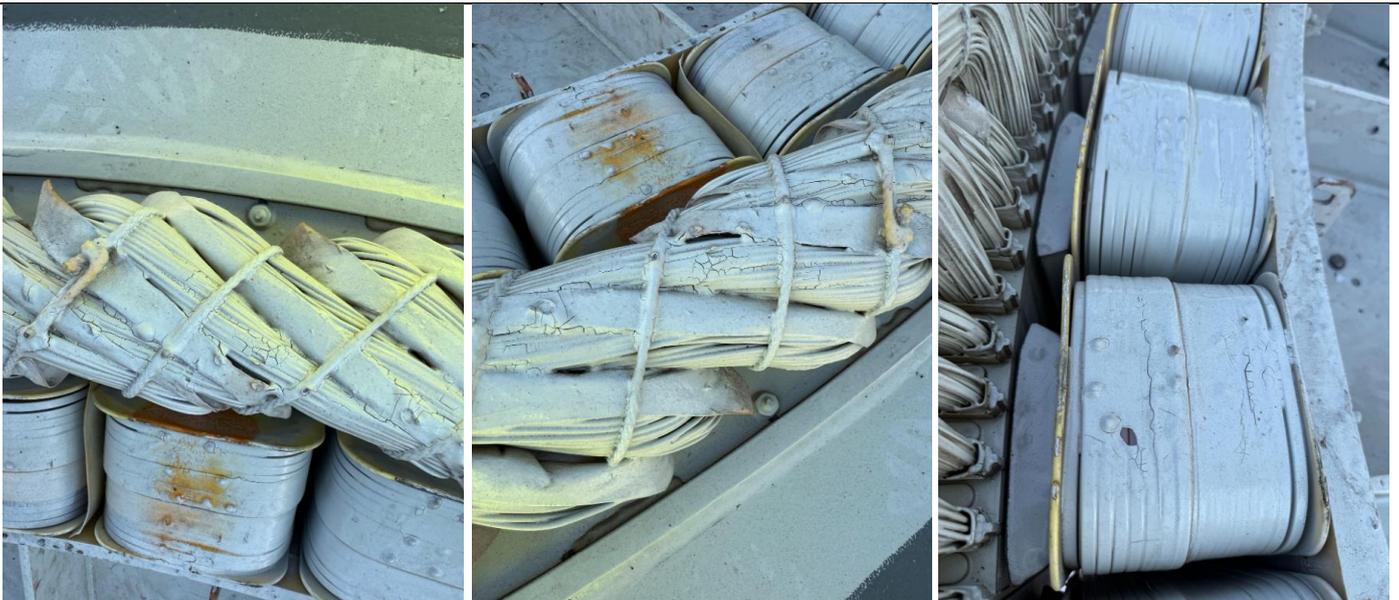
The generator and stator underwent a comprehensive visual inspection, during which they were found to be in a significantly deteriorated state. Extensive degradation of the resin insulation was observed, indicating that the protective resin coatings had become brittle, cracked, or broken down over time, which could compromise electrical insulation and increase the risk of electrical faults. Additionally, widespread damage to the paintwork was evident, with areas showing signs of peeling, chipping, or bubbling, likely due to prolonged exposure to environmental elements or chemical reactions.

Corrosion was also observed extensively throughout both the generator and stator components. This corrosion appeared as rust and oxidation on metal surfaces, often accompanied by pitting and surface degradation, which can weaken structural integrity and negatively impact electrical performance. The combination of resin degradation, paint damage, and corrosion indicates a high level of wear and age-related deterioration, significantly impairing the reliability and safety of the equipment.

Given the severity of these issues, a detailed assessment is necessary to determine the extent of repairs or refurbishments required to restore these critical components to a safe and operational condition. The observed deterioration underscores the urgent need for thorough cleaning, repair, and possibly replacement of affected parts to ensure the generator can be safely returned to service and operate reliably in future use.
